Guided Wave Pipe Inspection and Monitoring System

TAKASHI KUROISHI*1
 NOBUHIKO NISHIMURA*2
 HIROTOSHI MATSUMOTO*2

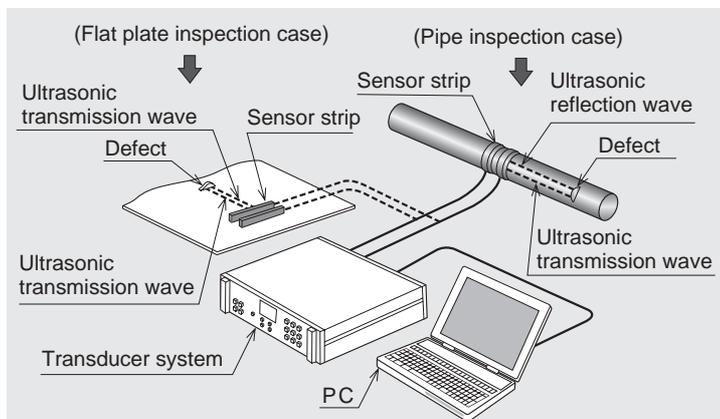
Fig. 1 System of guided wave pipe inspection and monitoring
 This system is composed of a sensor comprising pieces of magnetstrictive strip of Ni, etc. and coils, a transducer system and a PC for controls.

In the maintenance of thermal power plant piping systems dealing with wall thickness reduction of feed water pipe, etc., a very large number of UT inspections have been performed in recent years by removing the heat insulation work over the entire testing area and spending much time and labor. In the meantime, the applicability of a long-range testing method using guided wave has been confirmed in the petrochemical industry in the United States and this method has already been used for pipeline, etc.⁽¹⁾ As this technique enables reduction of the testing cost and provides sophisticated maintenance techniques by structural health monitoring, it would be used widely for application to piping in thermal power plants, etc. in the future. This report deals with the guided wave pipe inspection and structural health monitoring system (G-Monitor) built up through various verification tests of piping in thermal power plants. Fig.1 shows the system of the G-Monitor.

On the other hand, its level rises greatly to override a large obstacle encountered. Such an obstacle may be likened to a defect and the tsunami water level to the echo oscillation amplitude. Fig. 1 shows the system of the G-Monitor, which transmits the guided wave (having such characteristics) to the pipe. Pieces of strip of a metal such as Ni are bonded to the outer surface of the pipe using an adhesive and lead wires are wound on their outer surfaces like coils to form a sensor. The guided wave transmitted from the sensor propagate in the axial direction of the pipe, and when there is a section area loss in the pipe due to the existence of a flaw or a wall reduction, a transmitted wave is reflected from that position. The distance from the sensor to the damage portion can be estimated in terms of the round traveling time from sensor through the damaged portion. The size of the area reduction can be estimated by the echo amplitude of the reflected wave.

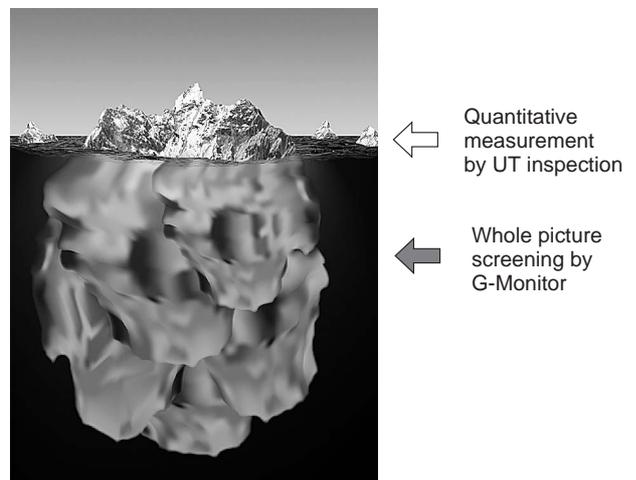
Fig. 2 Image of iceberg whole picture screening by G-Monitor

The role sharing between G-Monitor and UT inspection can be better understood by the image of an iceberg shown in Fig. 2. By using conventional UT method, we can only see part of the iceberg and it is difficult to image the whole of it. So in a manner of speaking, the role of the G-Monitor is to figure out the whole picture of the iceberg, and the role of the UT inspection is to test in detail the part of the iceberg that is visible above the water.

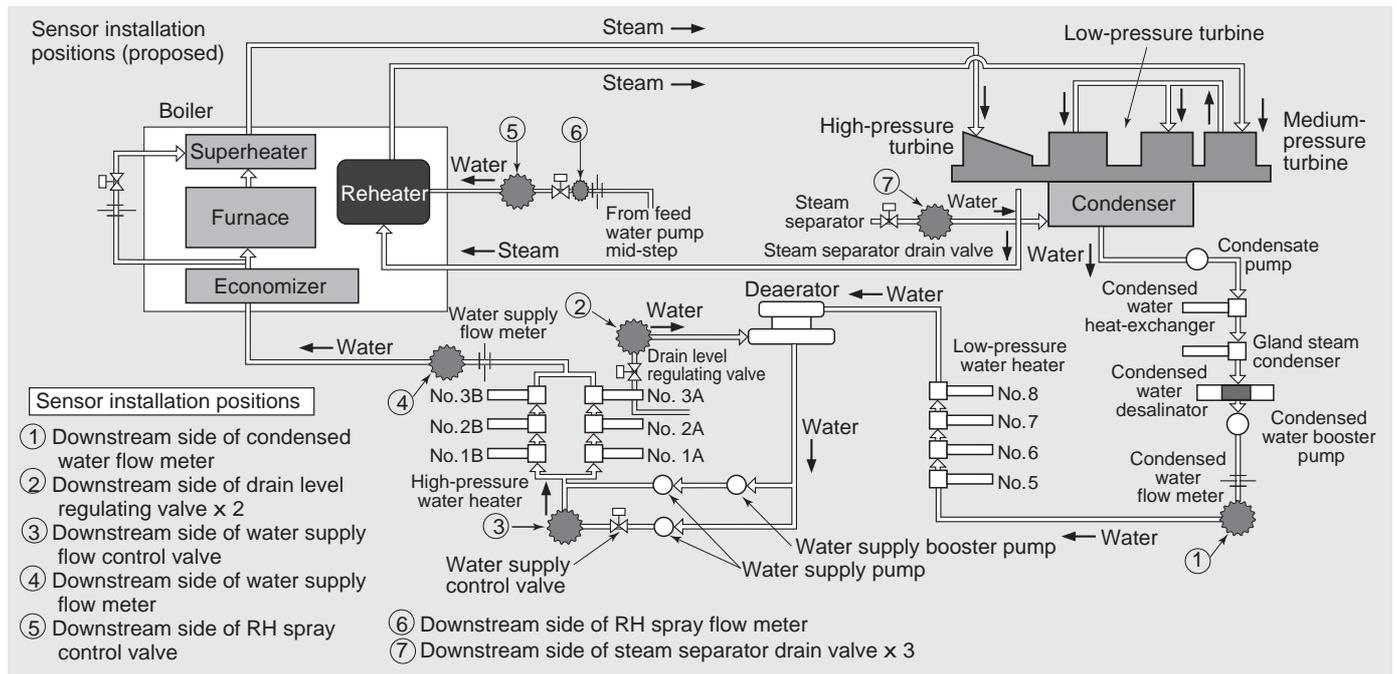
Fig. 5 Example of G-Monitor installation at thermal power plant

Various verification tests were performed with a view to applying the G-Monitor to piping at thermal power plants. Results confirmed that this system is capable of detecting gradual pipe wall thickness loss as well as flaws in straight pipe, pipe elbow and pipe diameter reducer. Fig. 5 shows an example of where in the thermal power plant piping system the G-Monitors may be installed. The results of the various verification tests performed are described below:

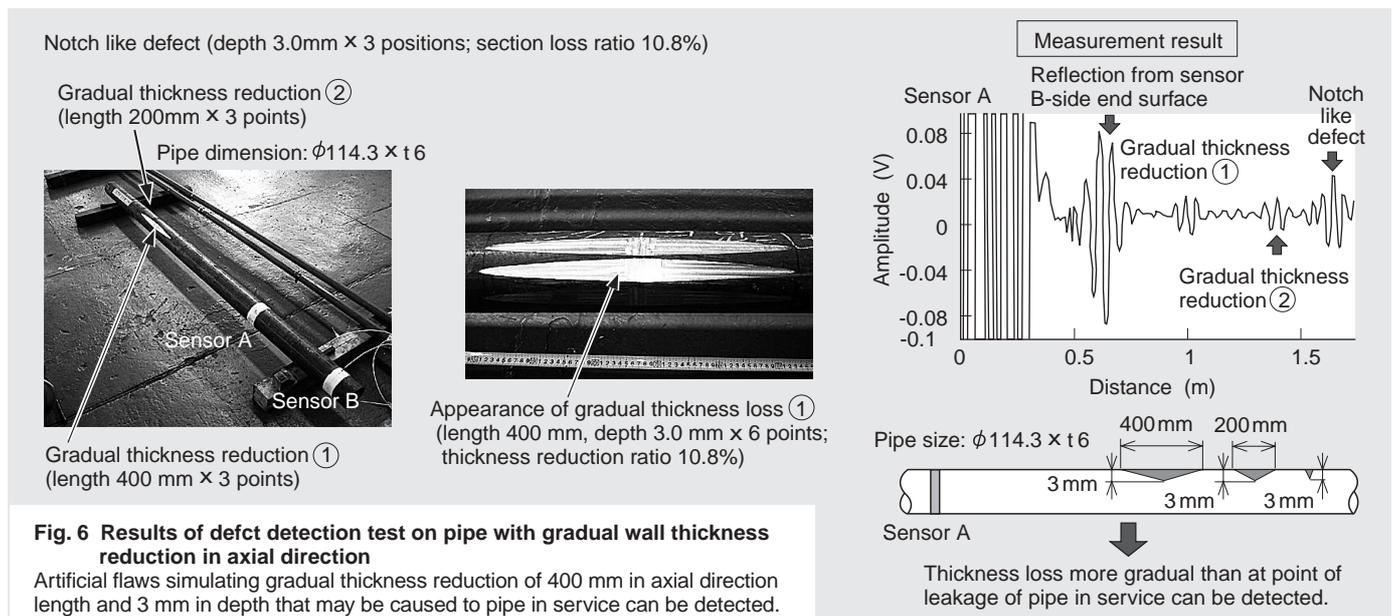
Fig. 6 Results of defect detection test on pipe with gradual wall thickness reduction in axial direction

Artificial flaws simulating gradual thickness reduction of 400 mm in axial direction length and 3 mm in depth that may be caused to pipe in service can be detected.

prone to be in the axial direction. Reduction area detection tests were performed on pipes artificially simulating three types of defects: a gradual axial direction wall reduction 3 mm in depth and 400 mm in length; 3 mm in depth and 200 mm in length, and a 3 mm depth notch like defect. Here, the artificial defects section loss ratio was 10% in all three specimens. Fig. 6 shows the results of the measurement tests. Although the echo amplitude values of the two artificial gradual thinning areas were approximately half of the value at the notch like defect, amplitude due to the reflection from those two gradual thinning showed twice as high as the noise. This test results indicates that gradual thinning can be detected by guided wave inspection

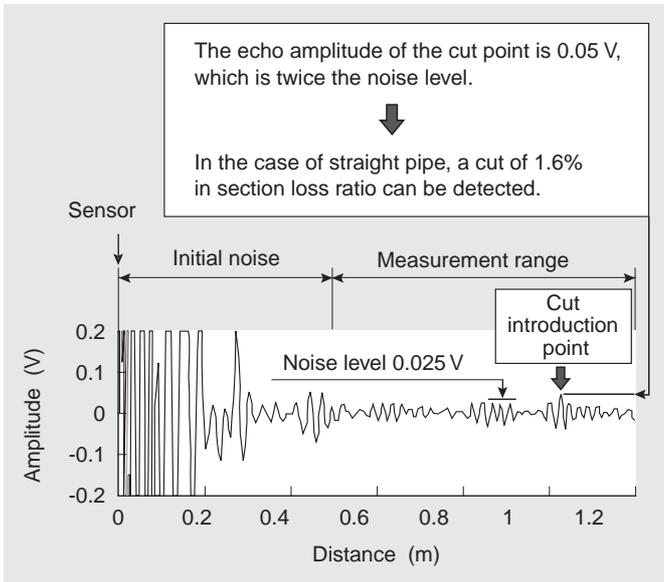
Fig. 7 Defect detection limit in straight pipe
Notch-like cut flaw of 1.6% in section loss ratio can be detected.

Fig. 7 shows the measurement result of a cut with a section loss of 1.6% introduced to a straight pipe. The echo amplitude at the cut point is twice the value of the noise level of the range subject to measurement. Flaws of section loss ratios up to 1.6% can thus be detected.

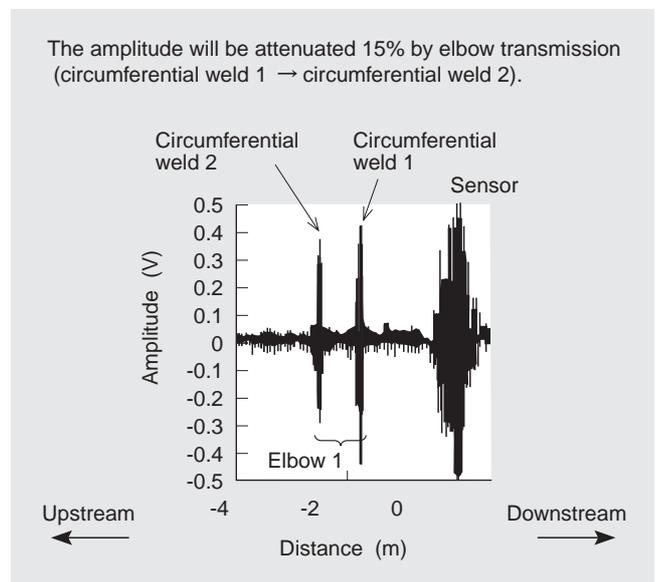
Fig. 8 Elbow section attenuation measurement result
Guided wave is attenuated 15% by elbow transmission.

Fig. 8 shows the result of measurement at the elbow section. A change was seen in the echo amplitude between the circumferential weld 1 and the circumferential weld 2 before and after the elbow section. Approximately 15% attenuation was found, revealing that guided wave is attenuated in the elbow section.

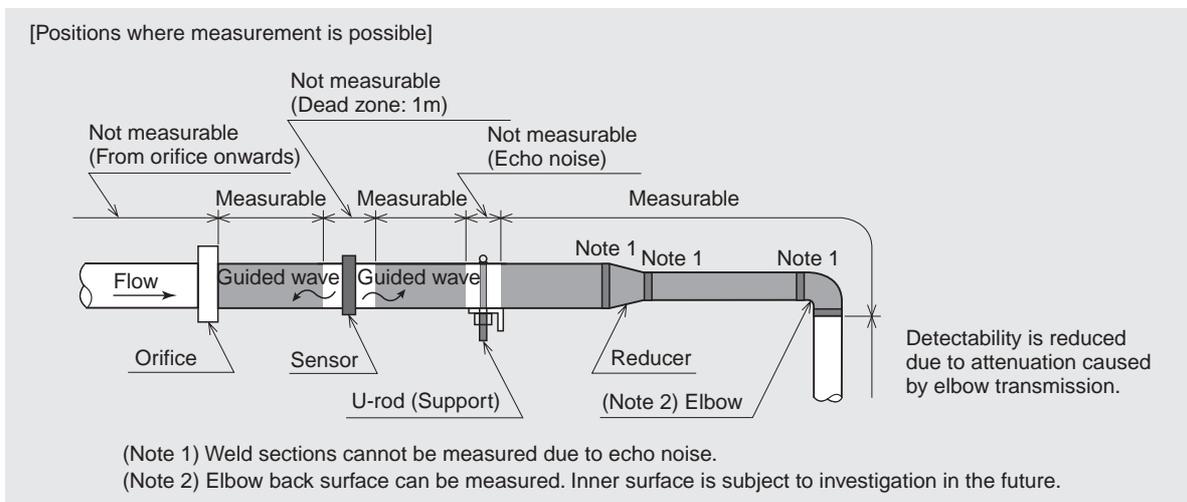
Fig. 9 Positions measurable by system available at present
When guided wave passes the elbow, it is attenuated so that positions after elbow transmission are subject to reduced detectability.

Fig. 9 shows the positions on the pipe where measurement is possible based on the influences of attenuation factors found as a result of the measurements performed so far.
