Visualization Technology for Internal Defects in Refractory Walls of Furnace Plants Using Non-Contact Acoustic Inspection Method

Conventionally in waste incineration facilities, the integrity of refractory walls of the boiler furnace is checked visually and/or by tapping. Tap inspection is widely applied because of its simplicity involving only hammer tapping and listening to the sound that is made. However, tap inspection also has problems in the case of the inspection area being of a great height and/or covering a large area, such as temporary scaffolding being expensive and criteria of inspection and interpretation of the results depending on individual inspectors. These issues are expected to be solved by Non-Contact Acoustic Inspection (NCAI). So, Mitsubishi Heavy Industries, Ltd. (MHI), together with Toin University of Yokohama, trialed the use of NCAI for refractory wall inspections and assessed its performance in terms of identification of internal defects in test pieces into which simulated defects had been added. The results show that a 200-mm-square defect, which is the identifiable minimum defect size by the conventional tap inspection method, can be visualized and ide

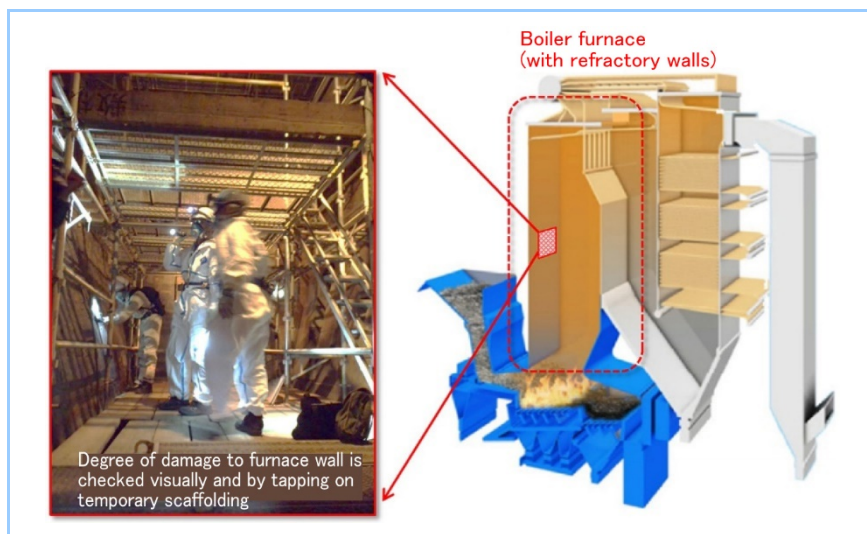
Figure 1 Inspection underway for refractory walls of stoker furnace at waste incineration plant

as waste incineration plants has the same issue as these concrete infrastructures. If refractory materials flake off from the wall while the plant is in operation and the water cooling tube in the wall gets exposed, it is considered that such exposure to high temperature leads to corrosion damage. It is also conceivable that a large amount of refractory materials falling from a considerable height and directly hitting/damaging the furnace facility will result in suspension of operations. To prevent this, the integrity of refractory walls is checked regularly, as shown in **Figure 1**.

In this study, the NCAI method is intended to be practically used for the waste incinerator shown in Figure 1. Considering its structure and size, the robustness was evaluated to show the impact of the applied attitude angle and straight-line distance between the measuring device and the inspection surface on the measurement performance.

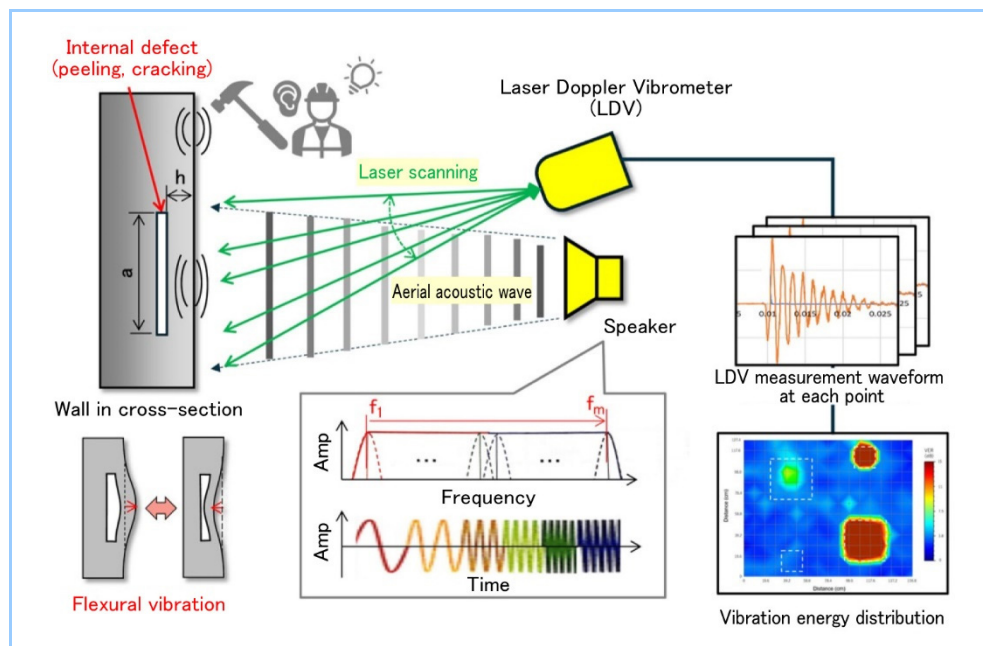
Figure 2 shows the measurement mechanism in the NCAI method. Suppose there is a defect with a size of “a” at a depth of “h” from the surface. The flexural vibration of this part is a resonance at the primary natural frequency (resonance frequency) as considered in the resonance model for a simply supported beam structure at both ends. The defective part can be distinguished from the remaining intact part based on the differences in the resonance frequency distribution. While also depending on the type of materials to be inspected (each with a different Young’s modulus, Poisson’s ratio and density), the flexural resonance frequency of a defective part in the same material is proportional to the depth of the defect and its planar area size.

Figure 2 Measurement mechanism of Non-Contact Acoustic Inspection (NCAI) method (in comparison with manual hammer tapping)

In the NCAI method, the mechanism for generating the difference in the sound between the defective part (with peeling and voids) and the integrity part is the same as that of the conventional tapping method. However, as an alternative to hammer tapping, the NCAI method uses aerial acoustic waves from a speaker to vibrate the surface of the inspection object. If there is a defect directly below the vibrating surface, the part immediately above the defect has a lower flexural rigidity than the integrity part. Flexural vibration is therefore likely to occur in this defective part.

In the tapping method, the sound generated by the vibration of the surface immediately above a defect slightly differs from the integrity part. The inspector listens and makes out this slight difference. In the NCAI method, on the other hand, the vibration of the surface immediately above a defect is directly measured by the laser doppler vibrometer, whereby the difference from the

integrity part is visualized quantitatively in terms of vibrational energy. The NCAI method therefore uses acoustic waves from a speaker instead of a hammer, and laser beams from the laser doppler vibrometer instead of listening to the sound. These means of non-contact measurement have enabled non-destructive inspection from afar.

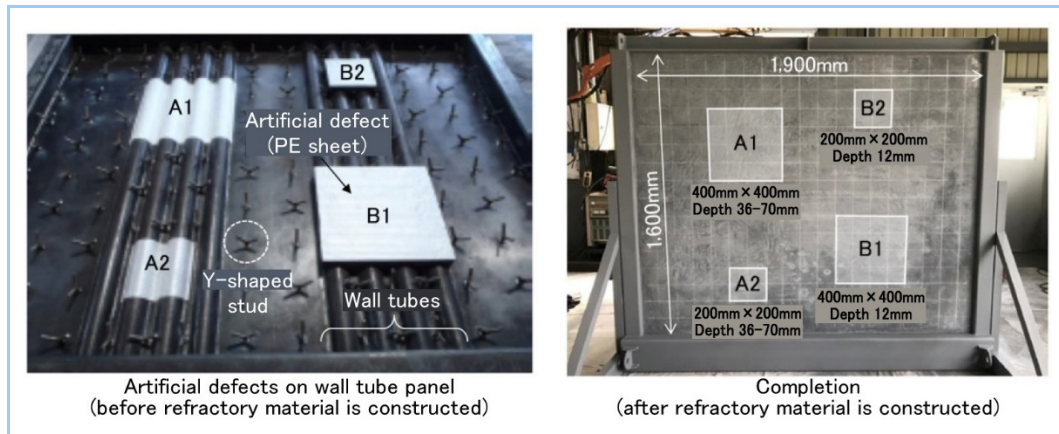
Figure 3 shows a refractory wall test piece with artificial defects, simulating the internal structure of a boiler furnace wall in general. This test piece is 1,600 mm length and 1,900 mm wide, with a 70-mm-thick SiC castable refractory material mounted onto a wall tube panel. The internal structure consists of multiple Y-shaped studs, wall tubes, and four artificial defects of simulated peeling.

As shown in the figure, artificial defects are fabricated by placing a 1-mm-thick polyethylene sheet in the predetermined positions before pouring a refractory material into the panel and letting it naturally dry and settle. The specifications of artificial defects are defined by two parameters, i.e., the depth from the surface and the size of the planar area. Supposing the occurrence of flaking due to anchor bolt corrosion, two depth levels from the surface were arranged: Type A (36 mm to 70 mm) along the curves of tubes, and Type B (12 mm, flat) over the top of Y-shaped studs. For the planar area, two sizes were prepared: Type 1 (400 mm square) and Type 2 (200 mm square). These are the typical sizes that are normally identifiable by inspectors. In total, there are four types of arrangements (A1, A2, B1 and B2).

Figure 3 Artificial defect-embedded test piece with simulated refractory structure with boiler wall tubes

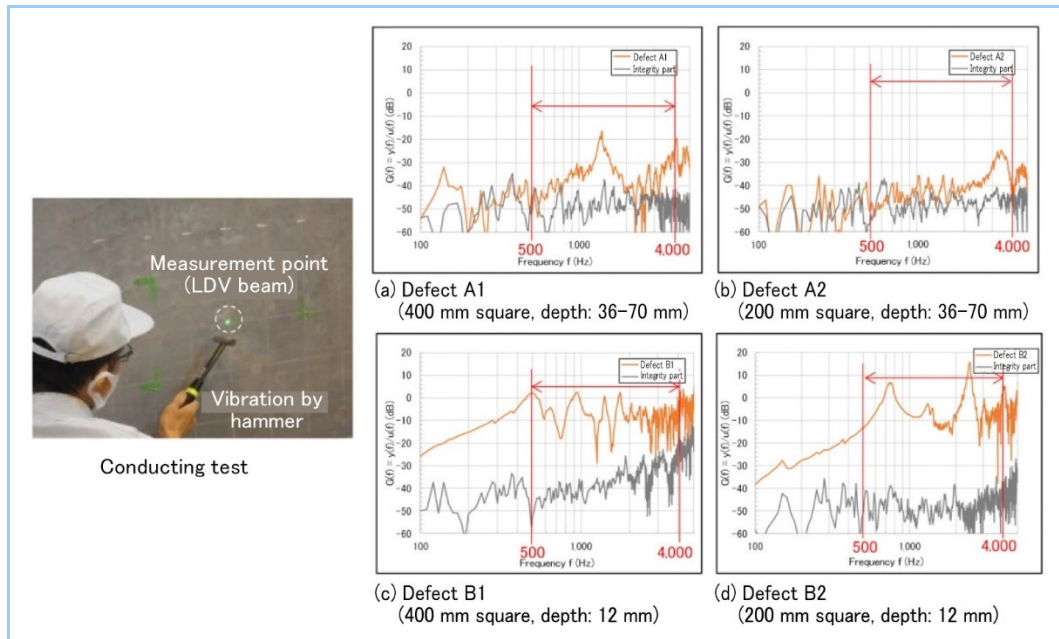
To determine the acoustic excitation frequency conditions for the NCAI method, the surface vibration characteristics of each of the defective parts and the integrity part were measured. The excitation force of a hammer was used as the input response, while the surface vibration by the laser doppler vibrometer was used as the output response. Based on their ratio, the flexural vibration characteristics were compared between the integrity part and the defective parts. **Figure 4** shows the results.

Consequently, a significant amplitude difference was confirmed between the integrity part and the defective parts in the band of 500 Hz to 4,000 Hz. Based on the results, multi-tone frequency acoustic waveforms in the flexural vibration band with the depth and size of these measured defects A1 were created. With the test placement shown in **Figure 5**, the acoustic wave was irradiated from the speaker to the test piece that was located 5 m away, facing the speaker. Simultaneously, the laser doppler vibrometer was used to scan the surface of the test piece with a laser beam. The surface area, which is 1,400 mm length and 1,700 mm wide, was divided by a 100 mm by 100 mm grid, thus producing a total of 238 measurement points (14 pts by 17 pts). The vibrational energy in the frequency band at each measurement point was visualized as a two-dimensional distribution.

Figure 4 Comparison of flexural vibration characteristics between each of defective parts and integrity part

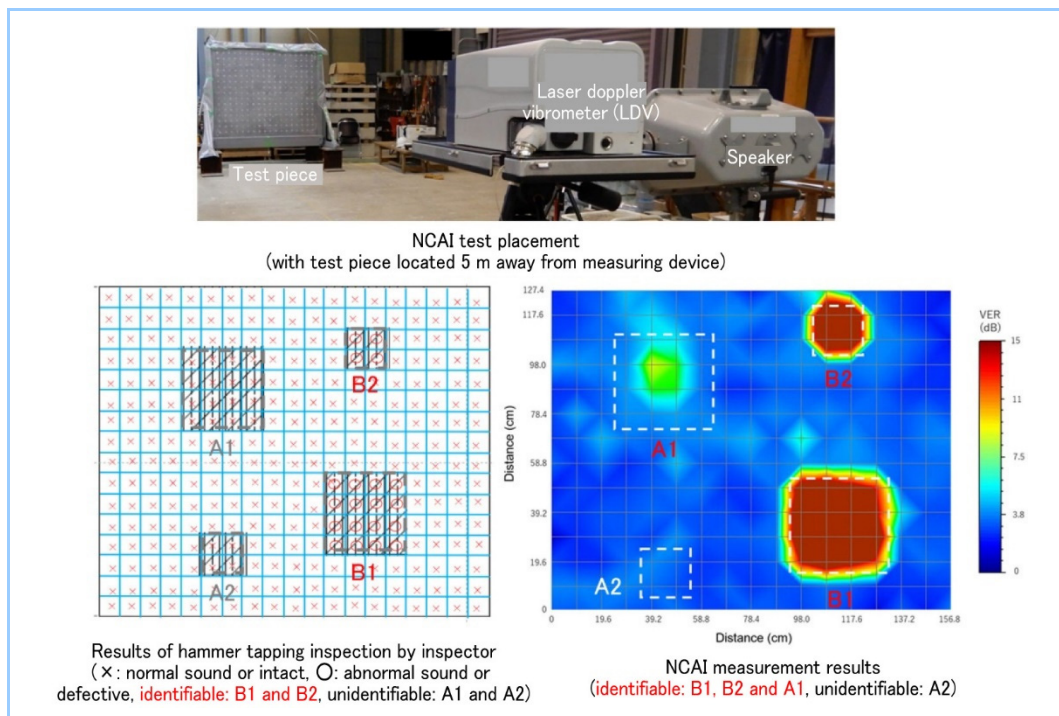
Figure 5 compares the results between the NCAI measurement and the hammer tapping by an inspector with 20 years of experience. The inspector using the conventional method could detect shallow defects B1 and B2, but not deep defects A1 and A2. On the other hand, the NCAI method showed, for B1 and B2, a vibrational energy difference of 15 dB relative to the surrounding integrity part, allowing them to be identified. Even a deep defect of A1 (400 mm square), which the inspector was unable to detect, had a vibrational energy difference of 6-8 dB, leading to successful identification.

Although the location of defect A1 was successfully indicated by the NCAI method, the identified size was smaller than the actual one, showing only a part of the entire defective area. This is presumably attributed to its three-dimensional shape. Unlike defects B1 and B2, which are in the shape of a plane parallel to the surface, Type A defects are three-dimensional along the curves of tubes in the test piece with varying depths at each measurement point. This makes the measurement conditions more complex than simply uniform flexural vibration characteristics. With regard to defect A2, the NCAI method also failed to detect this, as was the case with the inspector using the conventional method. In conclusion, the defective parts were able to be identified by a signal level difference of 3 dB or more, which is significant in measurement and serves as an indication for distinguishing a defective part from an integrity part. It has been demonstrated that the NCAI method can identify internal defects without contact as effectively as or better than the tap inspection by the inspector.

Figure 5 NCAI test placement and comparison of its defect identification results with hammer tapping method

Starting from the test piece's position being 5 m away facing the measuring device ($\theta = 0^\circ$, as shown in Figure 5), the angle was changed from 30° to 45° to 60° . The measurement results are compared in Figure 6 (a) to (c). Up until 45° , defects B1 and B2 can be distinguished from the surrounding integrity part. Reaching 60° , however, the borderline between the integrity part and the defective parts becomes unclear. Defect A1 becomes unidentifiable at 45° . This is believed to be

Figure 7 shows the measurement results of the test piece being located at a maximum straight-line distance of 10 m from the measuring device. When compared with **Figure 5** in which the test piece is 5 m away, the difference in vibrational energy between defect A1 and the surrounding integrity part is relatively lower, making the identification difficult. However, defects B1 and B2 are clearly identified, indicating the defect identification performance that is comparable to the inspector. These demonstration test results show the possibility of simultaneously inspecting an area with a maximum size of about 14 m square from same place, if the distance is 5 m to 10 m and the viewing angle within the range of $\pm 45^\circ$.

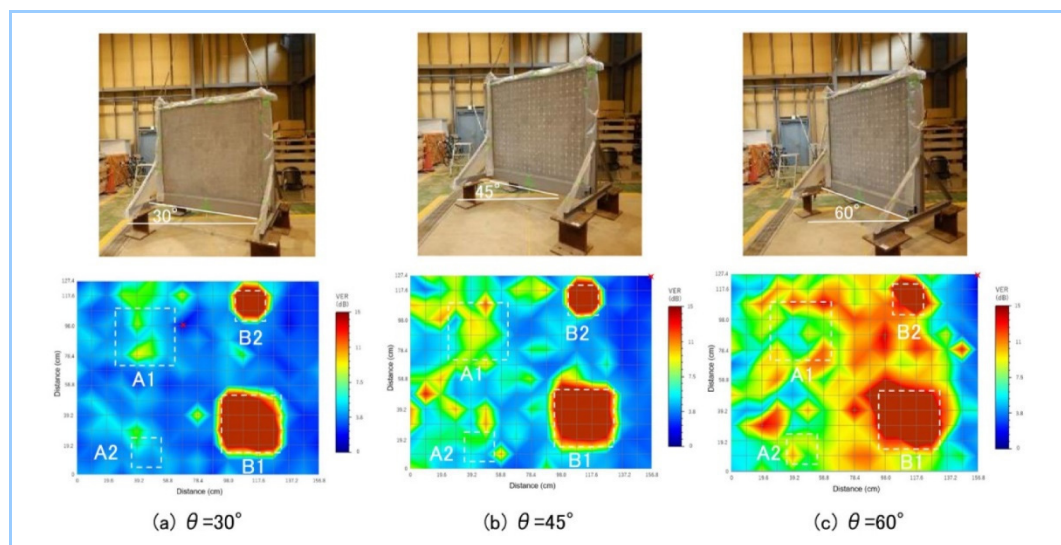
caused by varying phases at each measurement point with the incident angle of the excitation acoustic wave front. The multiple vibrational modes at the surface then become excited, allowing them to influence each other.

Figure 6 NCAI method’s dependence on measurement angle (upper: position of test piece, and lower: measurement results)

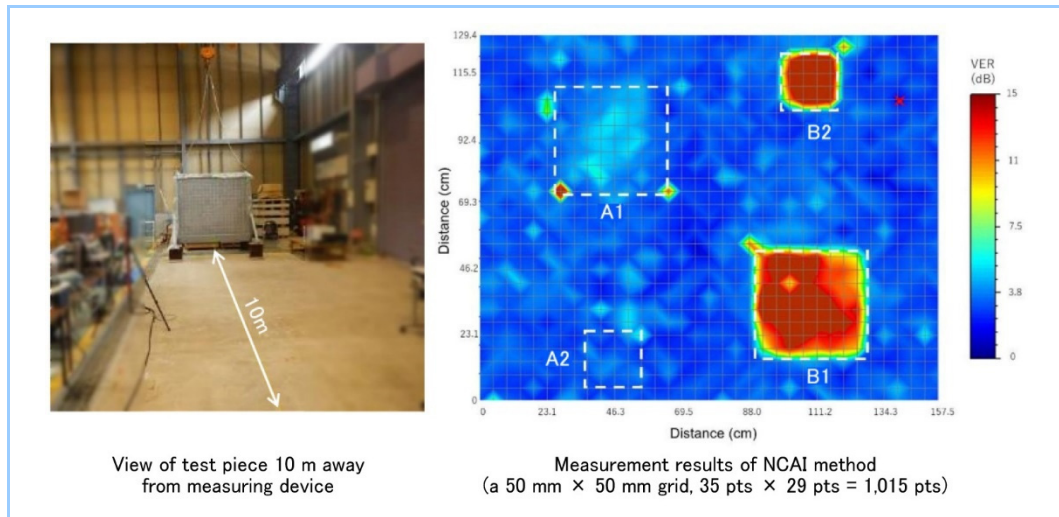
Figure 7 Measurement results of NCAI method with test piece at distance of 10 m
